12 September 2007

URBIS JHD
Level 12
120 Edward Street
BRISBANE 4000

Re: Inspection Properties 82 and 84 Fitzroy St. Warwick

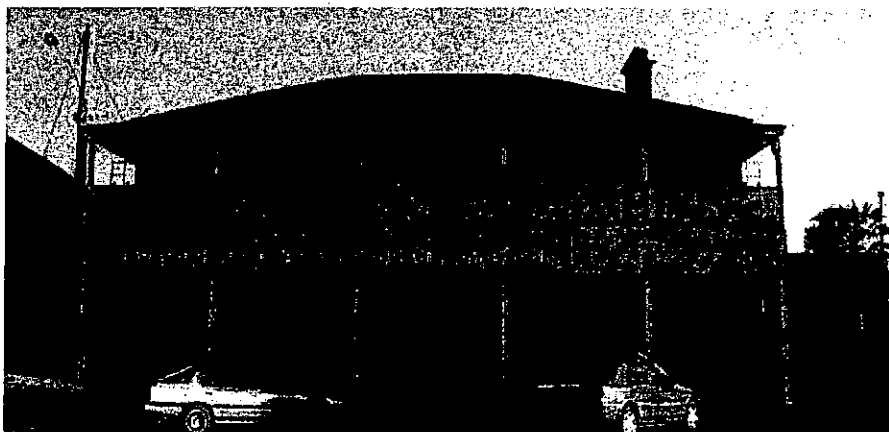
Photo 1.1 Front View Oct 2005

- 1.1 The building is a 2 storey structure constructed from loadbearing sandstone walling, possibly brickwork internal walling, with timber floor and framing approximately 100 years old. More recent additions exist to the rear of the site, comprising single storey timber framed additions. Photo 1.1 1.2 1.3.

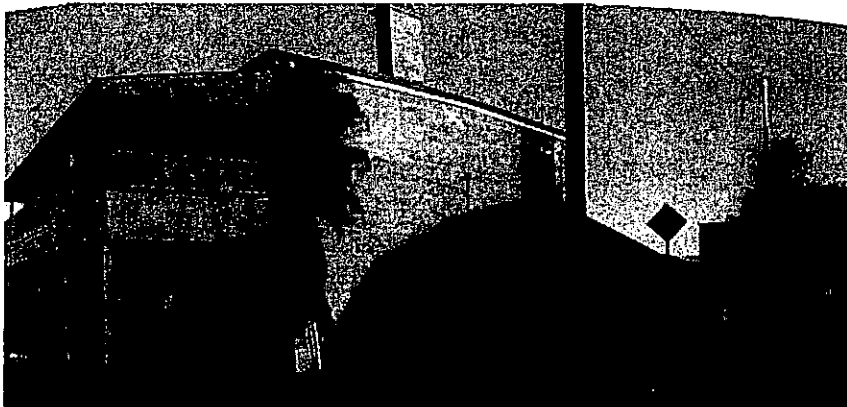
Photo 1.3 West Side View Oct 2005

The external walls have a number of tie rods connected to a cross of flat steel. One such can be seen in Photo 1.3. These generally occur at or adjacent to significant cracking in the external walls.

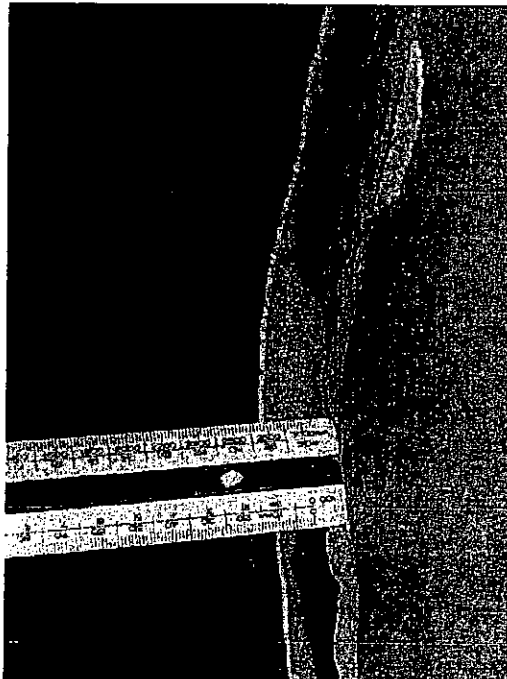
- 1.4 The external and internal walls exhibit extensive cracking with relative movements both translational and lateral. These cracks appear to coincide with cracking in external walls braced by tie rods referred to in section 1.1. There appears to have been further movement in the external walls between the earlier inspection and the more recent inspections. Photos 1.7 and 1.8 show an increase of approximately 5mm in the width of the same crack in the western wall in the intervening period, and similarly photos 1.9 and 1.10 are photos taken almost 2 years apart.

Photo 1.7 Oct 2005 15mm

- 3.3 The root cause of the cracking in the walls appears to be foundation movement, with the existing foundations laid on either weak and/or reactive ground, which has settled and been subject to changing moisture conditions over the years. This has resulted in significant differential movements and rotations in the walls, causing the observed cracking. The most alarming is along the western wall, where there are clear indications of significant outward relative displacements of part of the wall (Photo 1.8) of up to 25mm in the upper storey, and an increase in 5mm approximately from the earlier inspection in October 2005. This observed wall movement (which exists in all the internal and external walls to a greater or lesser degree) could be arrested by underpinning of the building foundations to a deeper more competent and less reactive strata. However, a full temporary shoring system supporting the wall to guard against the possibility of collapse using vertical walers and diagonal braces at reasonably close centres would be indicated.

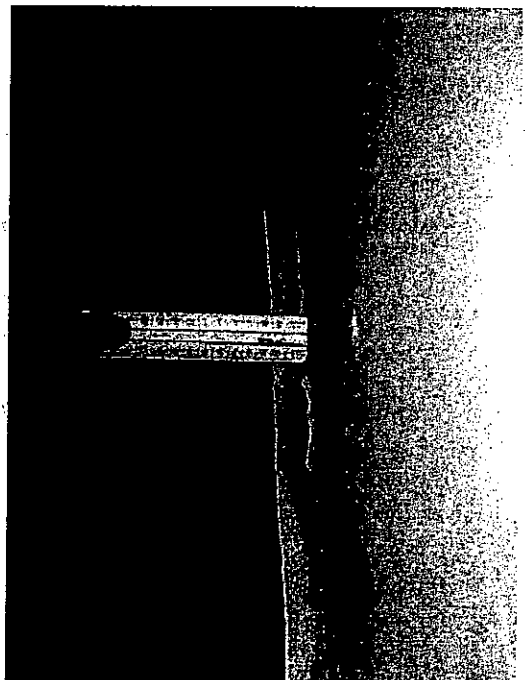
Photo 1.8 June 2007 20mm

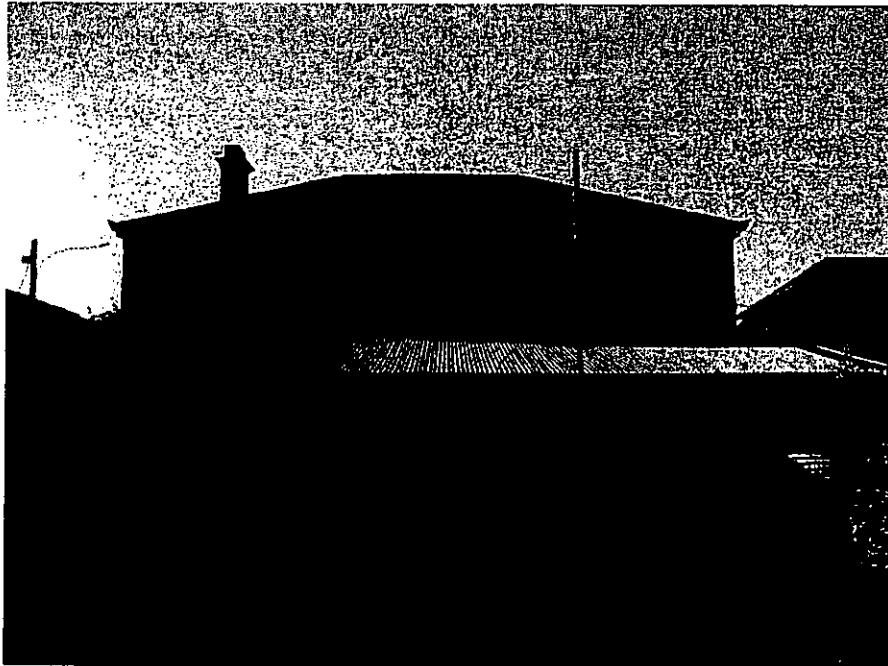
Photo 1.3 Rear Newer Building from rear yard June 2007

1.8 The newer rear addition is of timber framing on a slab-on-ground. The condition of this structure is reasonable.

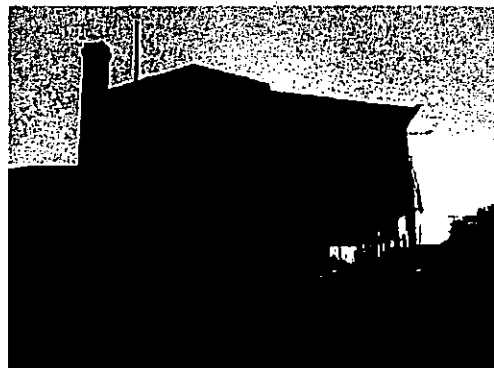
- 2.1 The eastern building is a brick masonry and timber framed structure on indeterminate age. The lower floor wall framing is masonry, with the upper floor of predominately timber framing. (Photos 2.1 2.2) Access could not be gained to the lower floor in June 2007 to assess the current condition.

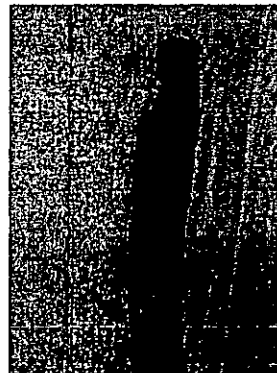
- 2.3 Evidence abounds of termite and rot damage in walls skirtings and mouldings. Photos 2.5 2.6

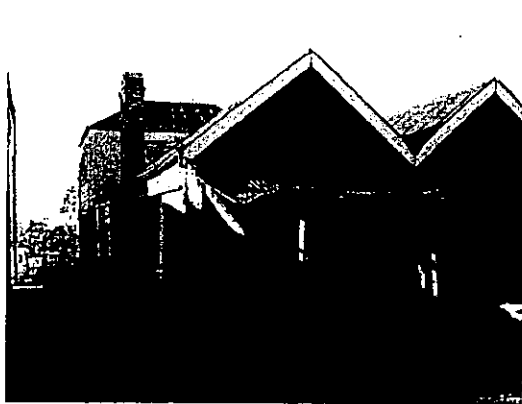
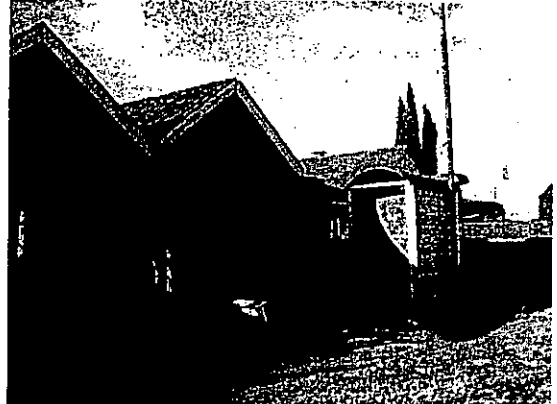
2.4 The rear verandah framing is on the verge of collapse. Photo 2.7, 2.8.
