# **PROPOSED EXTRACTIVE INDUSTRY OPERATIONS AT DONNYBROOK**

## **Acid sulphate soil management plan**

**CSR LIMITED**

BC4616-G-DO-505 Rev 1

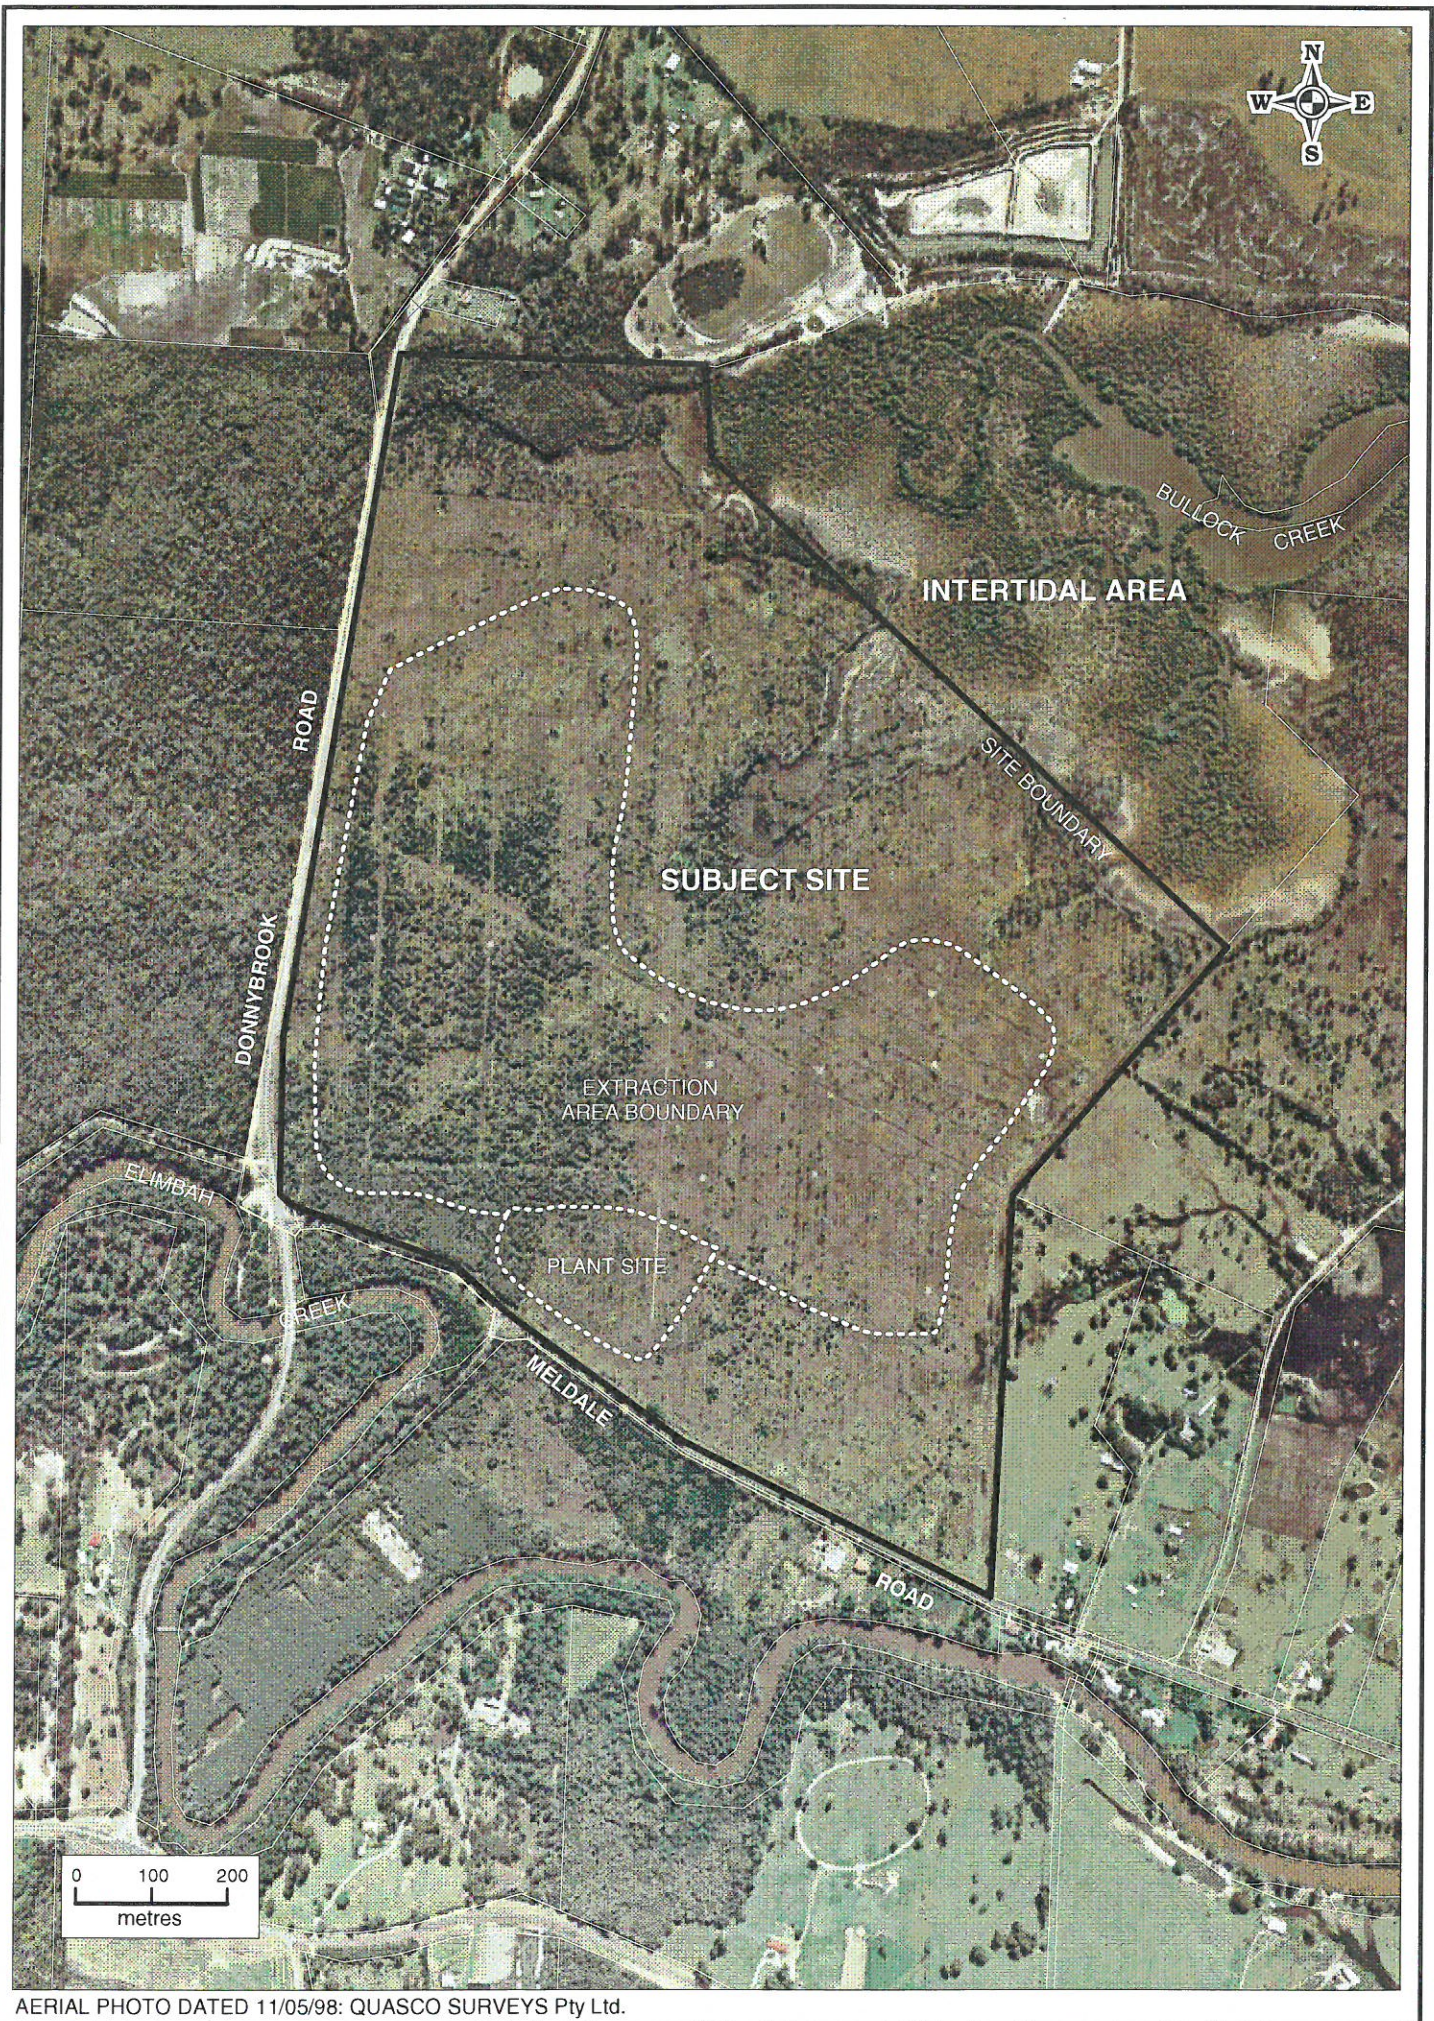
**Figure 2.5**  
**EXISTING SITE CHARACTERISTICS**

AERIAL PHOTO DATED 11/05/98: QUASCO SURVEYS Pty Ltd.

Figure 2.5 shows the existing site characteristics.
