Historic photographs of timber treatment works at Martin Street, Armidale

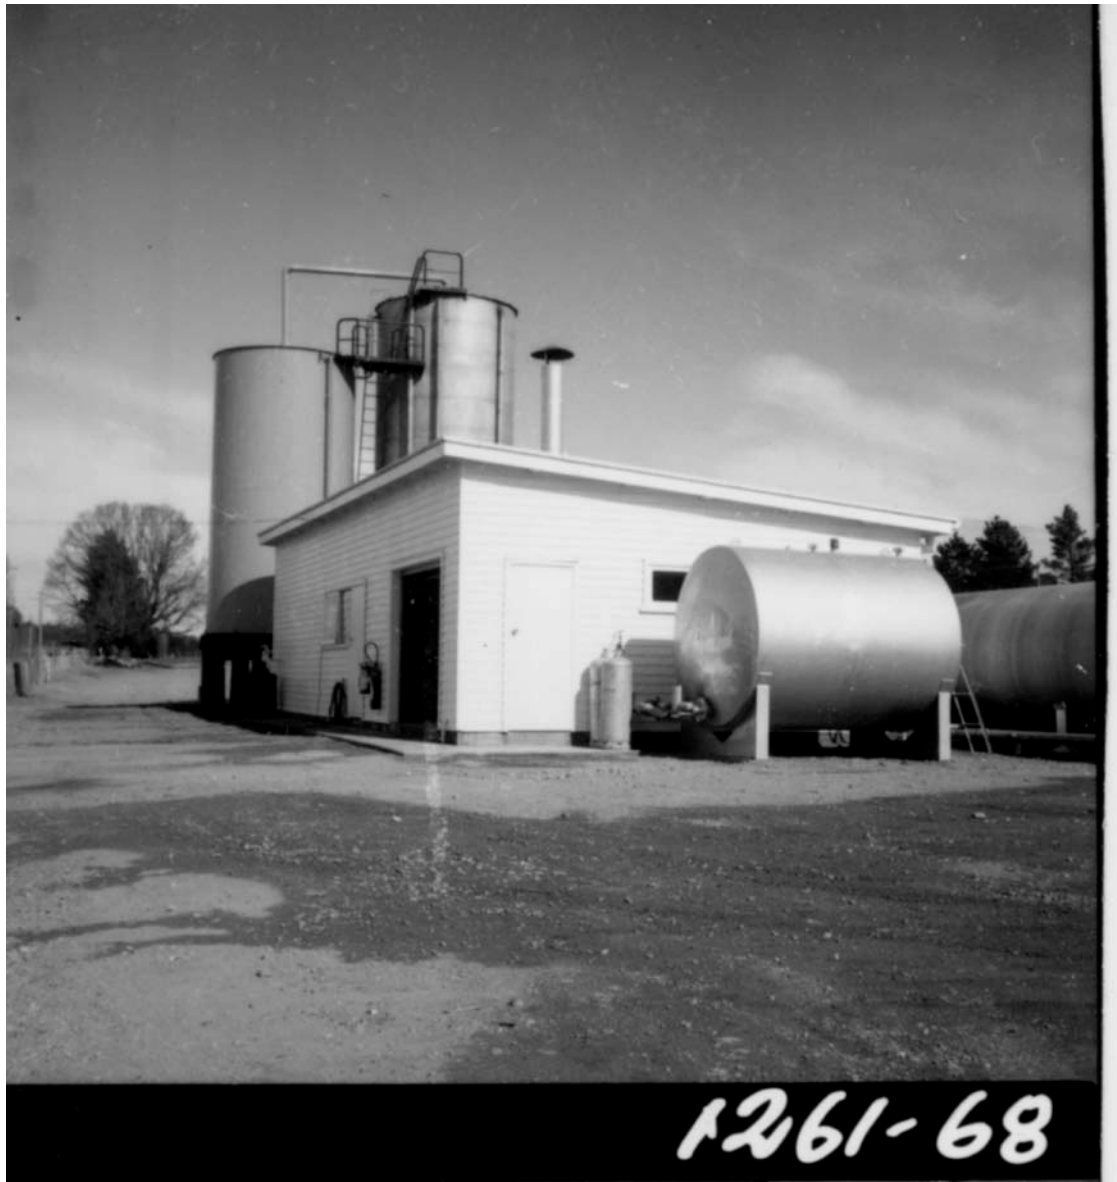
Figure 3: Timber treatment works at Martin Street, Armidale ca 1968. Note that part of the 75 foot cylinder for timber impregnation shown in Figure 5 is visible on the right of this photograph. Source: Armidale City Council file

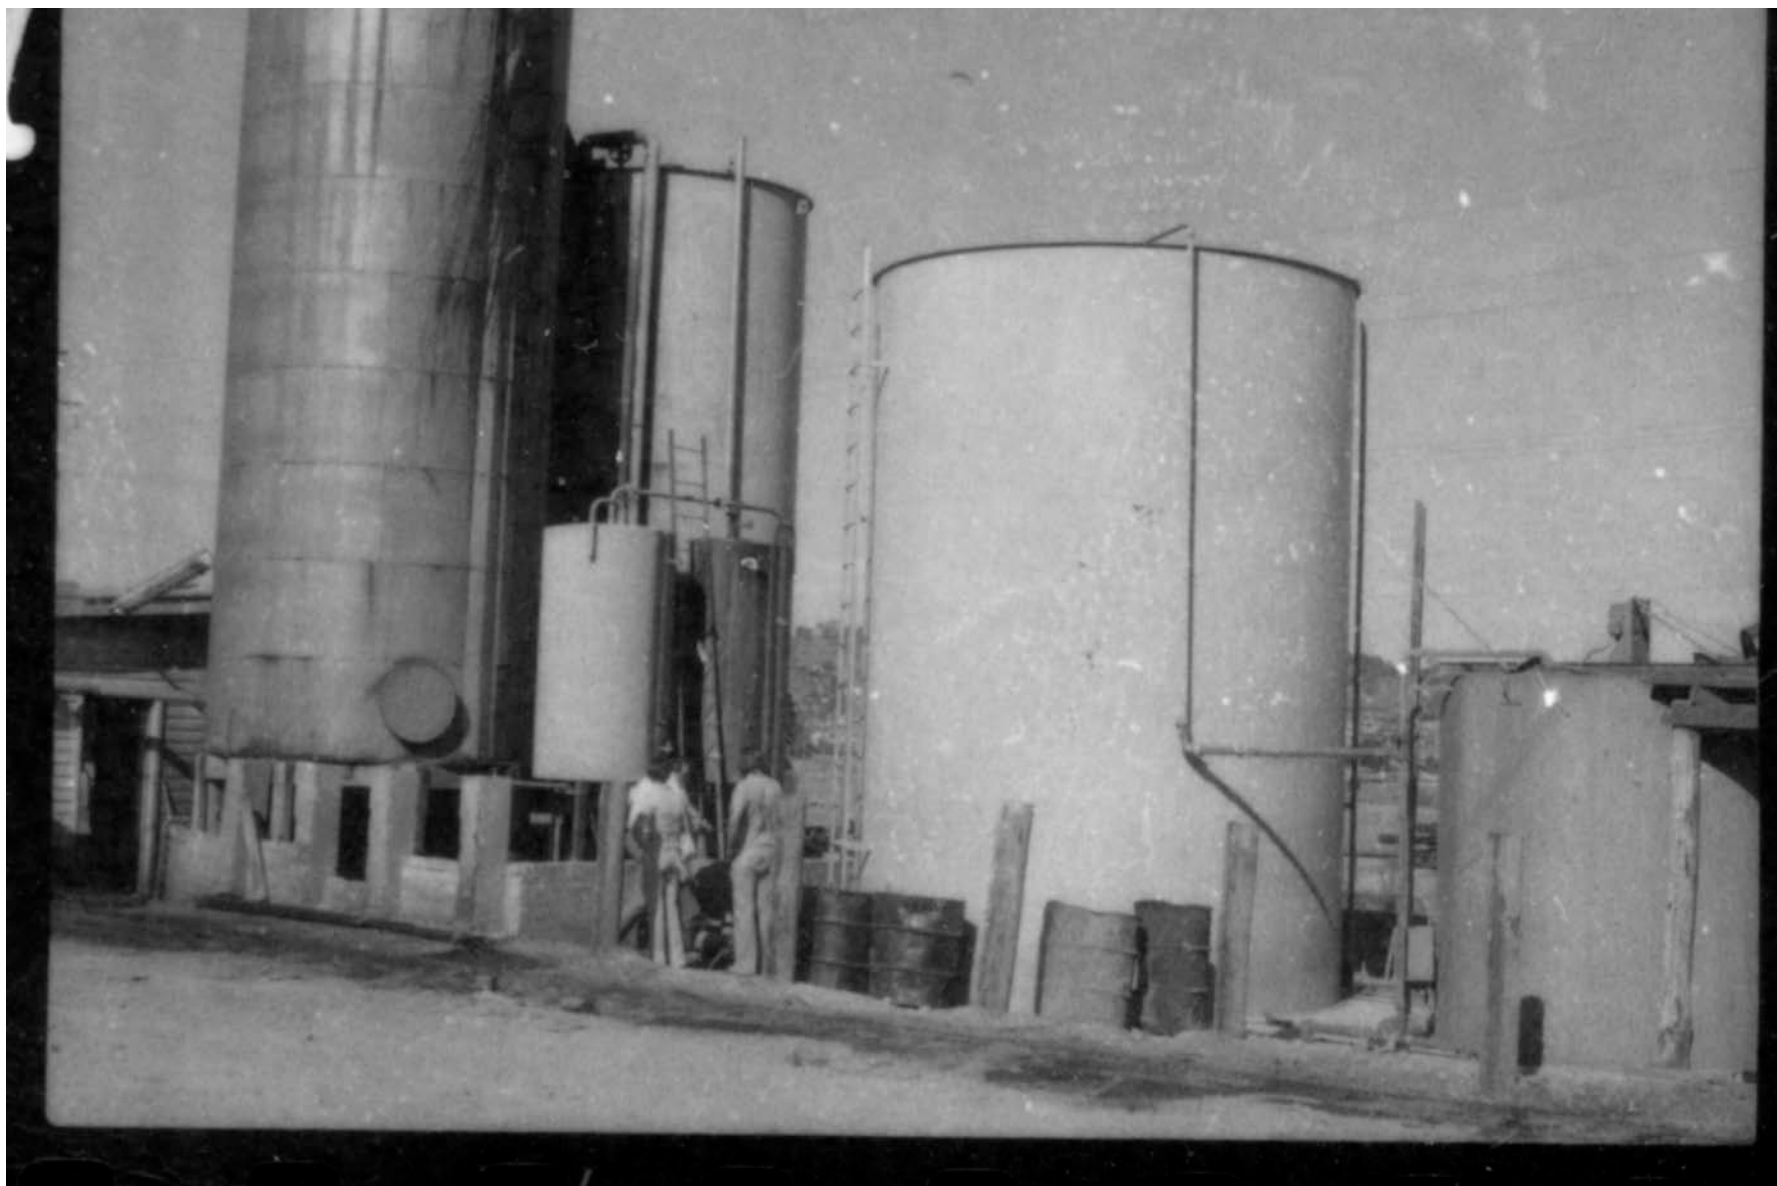
Figure 4: Storage tanks at timber treatment works at Martin Street, Armidale ca 1968

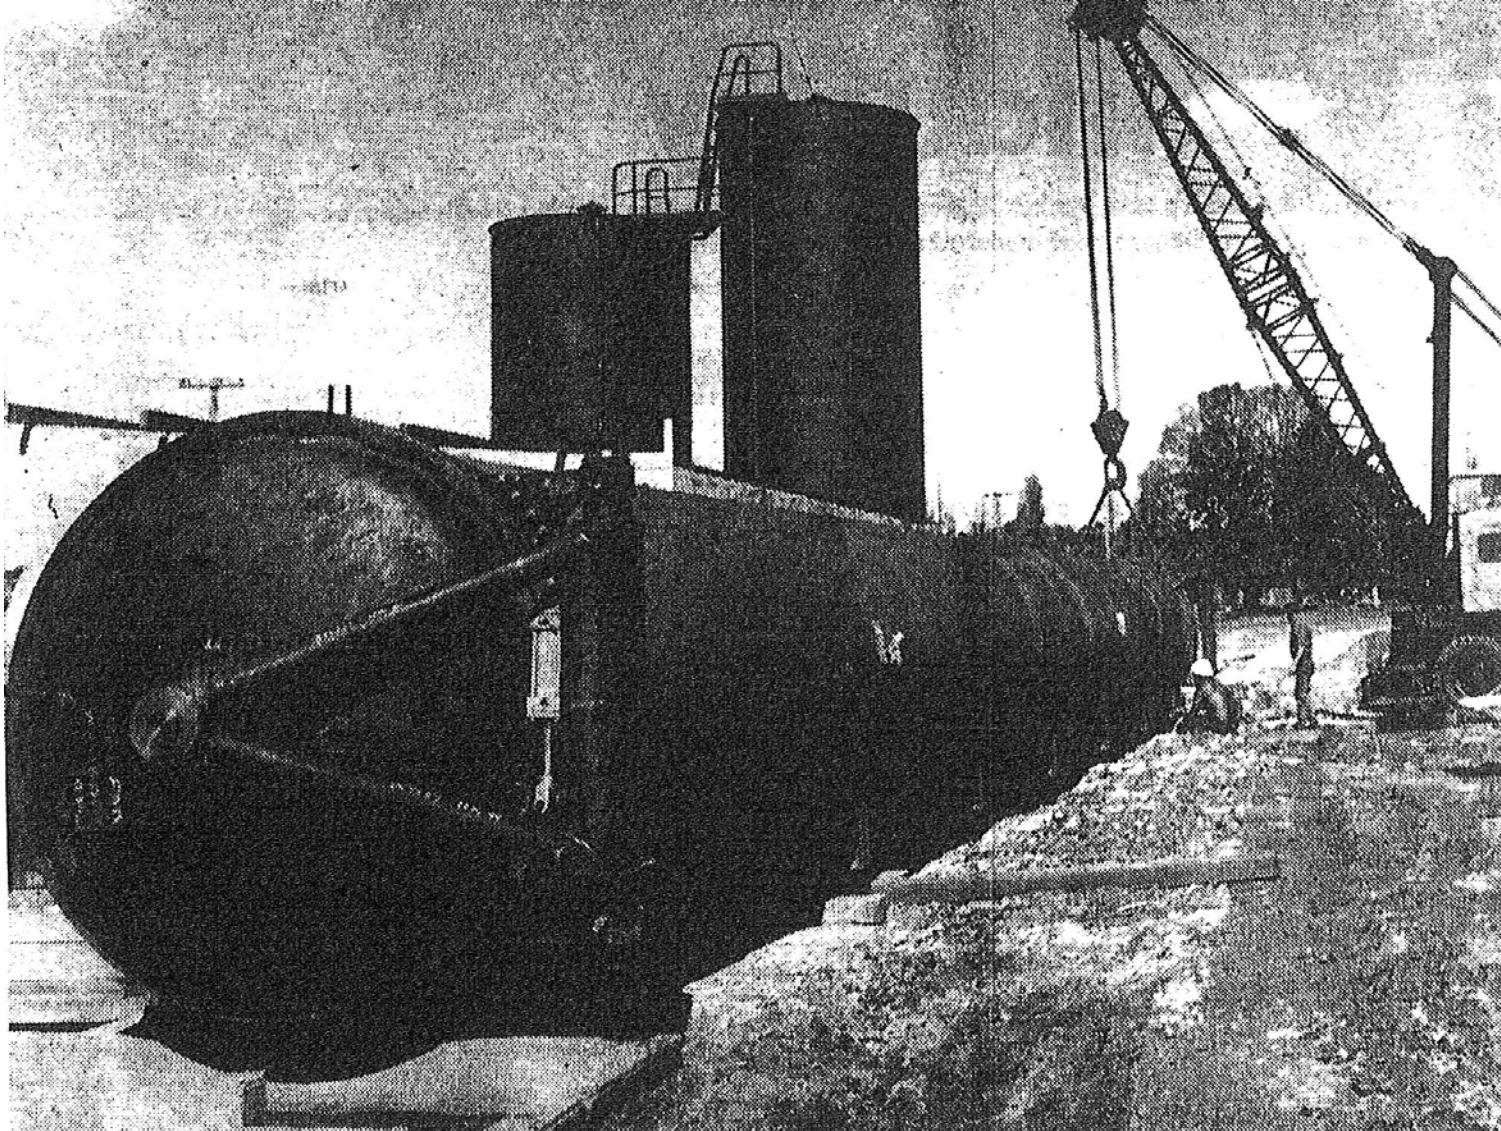
Figure 4: The 75 foot timber impregnation cylinder at the timber treatment works at Martin Street, Armidale 1968. Note storage tanks in background are the tanks shown in Figures 3 and 4. Source: The Armidale Express, 21 June 1968, p 13.

- The impregnation cylinder is 75 feet long, with an internal diameter of 6 feet. Creosote, supplied by rail from Union Carbide at Rhodes Sydney is stored in tanks with a total capacity of 22,000 galls. The creosote is circulated in the pressure cylinder at 200 psi and at a temperature of over 200° F.
